# University of Nevada, Reno Argenta Hall Explosion Event July 5, 2019

**Brennan Paterson**  
Chief Administrative Officer  
Mechanical Compliance Section  
State of Nevada Division of Industrial Relations  
July 23, 2019

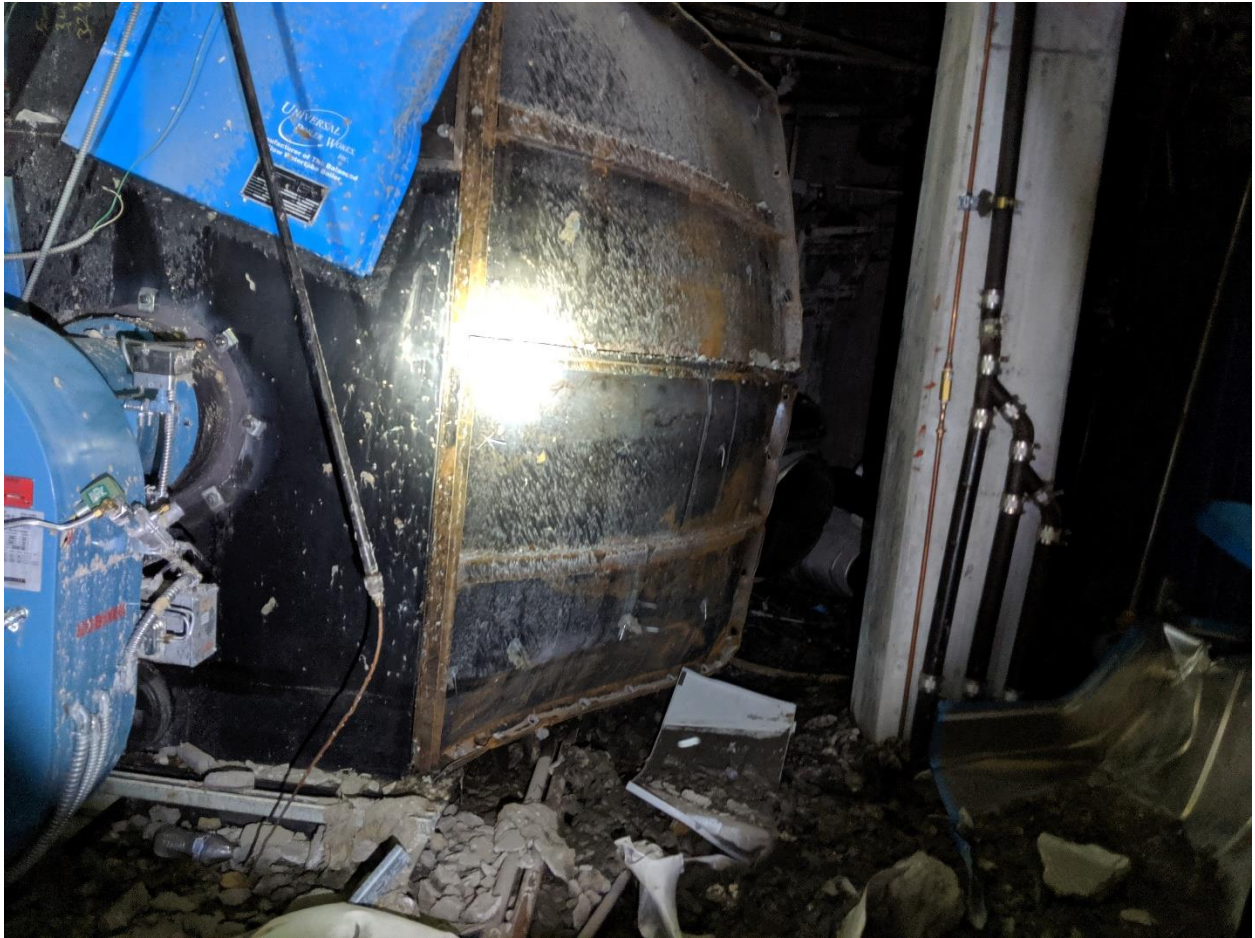
After completing the replacement of a servo-controlled gas metering valve on Boiler #1, the boiler mechanic attempted to restart the boiler several times. During the course of restarting the boiler, the furnace and exhaust assemblies of the boiler exploded in a fashion consistent with those assemblies having been charged with an unburned fuel and air mixture (see figures 1, 2, 3).

**Figure 1.** A front view of Boiler #1, showing damage from internal explosion of the furnace assembly.

The initial explosion in Boiler #1 was caused by the existence of an explosive mixture of fuel and air in the furnace and exhaust sections of the boiler. Evidence is inconclusive as to the actual cause of ignition, though ignition may have been caused by the boiler igniter being actuated or by residual heat in the boiler as a result of previous attempts to start combustion. This boiler was equipped with a purge fan which, under normal operation, will clear these assemblies of any unburnt fuel/air mixture. It appears that this fan was not engaged during the attempted start of Boiler #1. Due to damage from the explosion, this fan could not be tested for functionality.

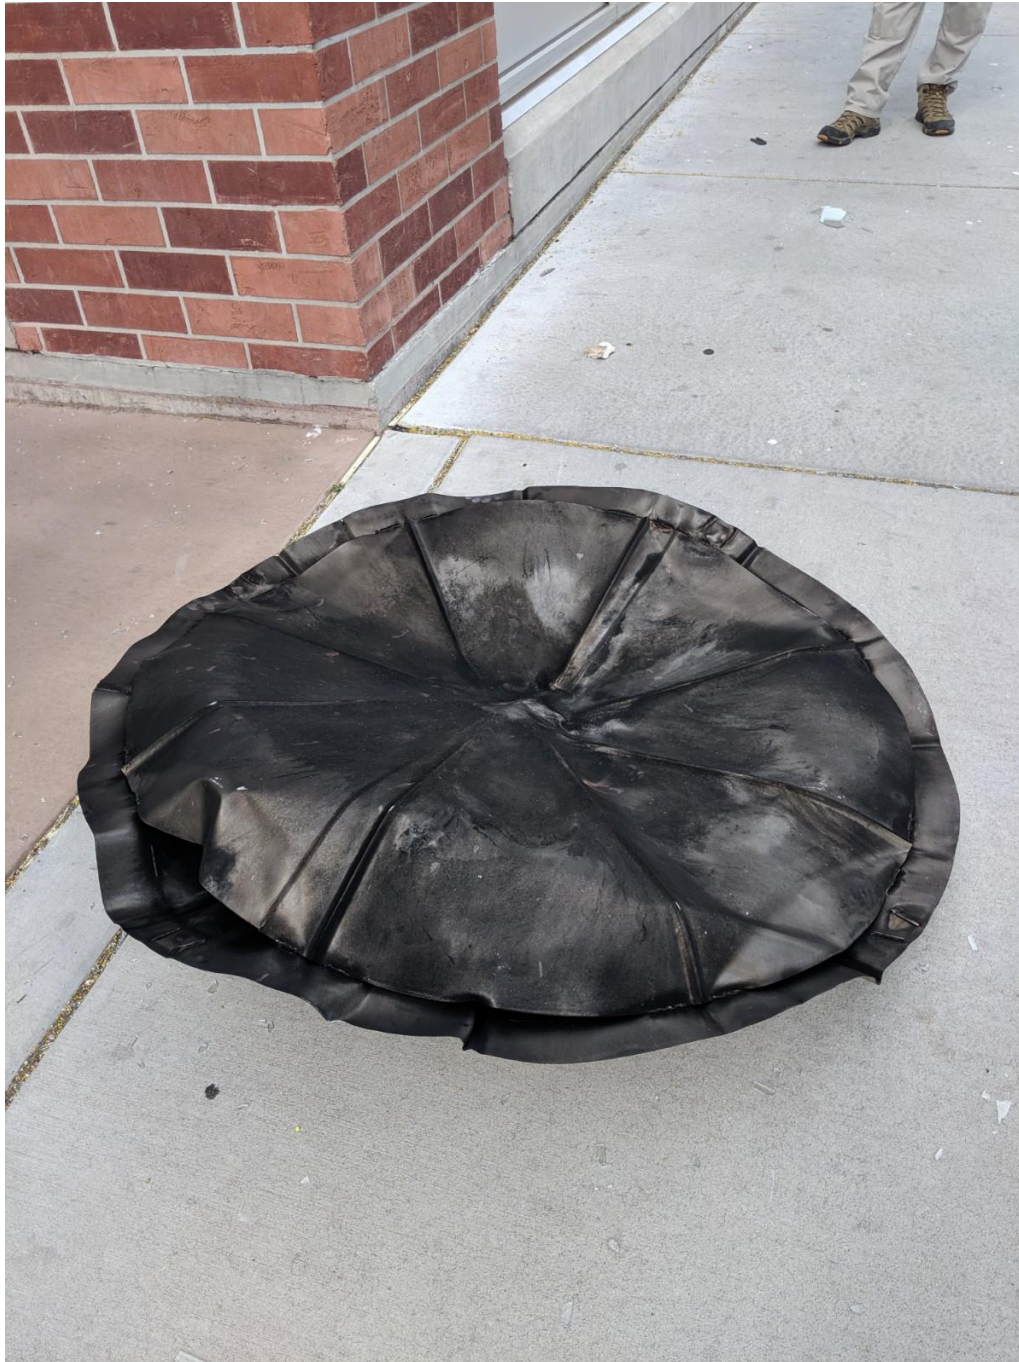
**Figure 2.** Rain shield from Boiler #1 exhaust assembly, found on the North side of Nye Hall. Damage is consistent with an explosion within the exhaust assembly.

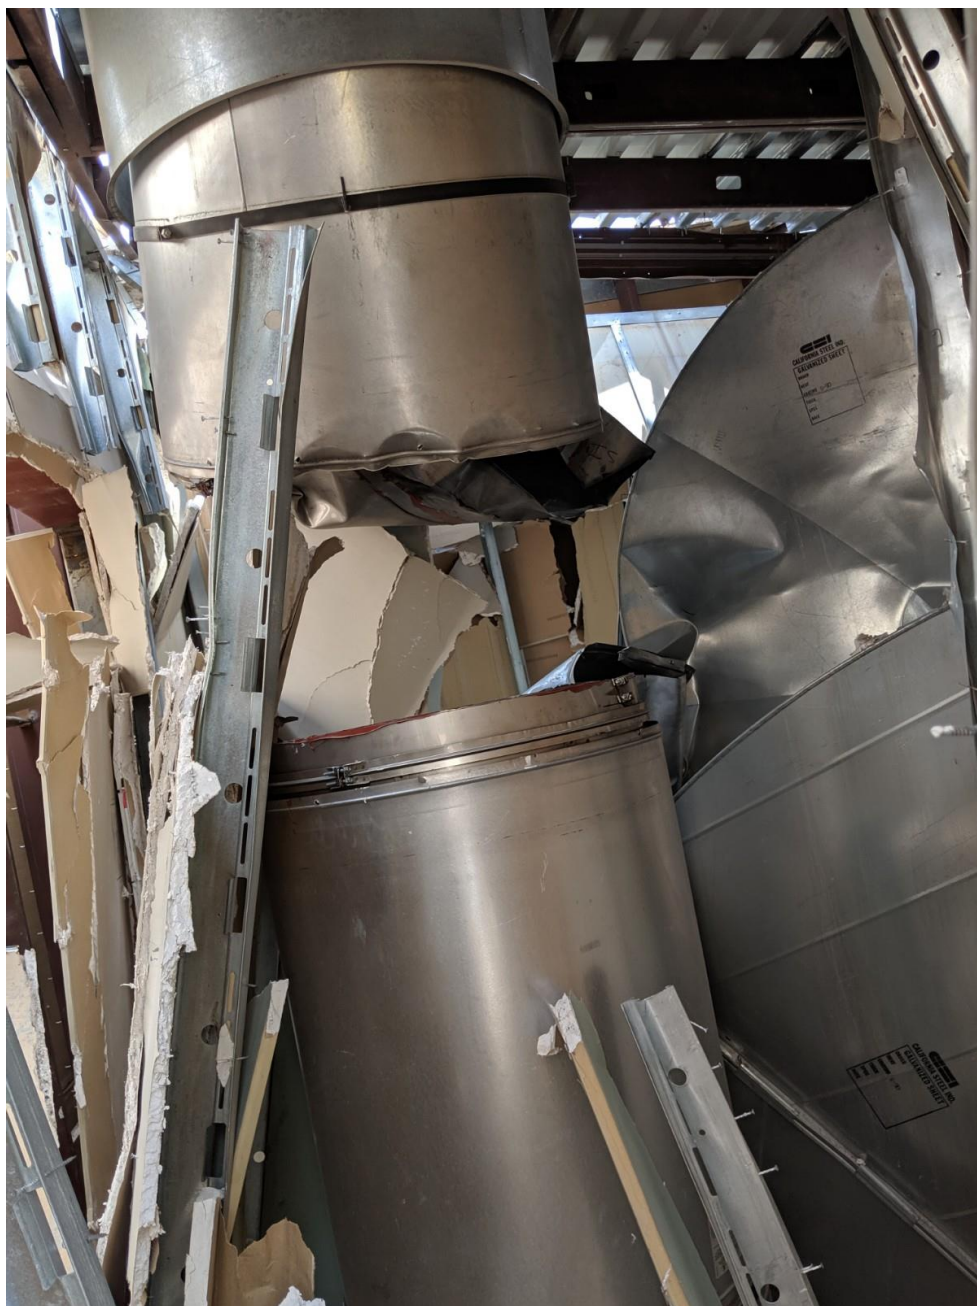
**Figure 3.** Exhaust assembly from Boiler #1. This is the view inside of the ducting area on the roof of Argenta Hall. Damage is consistent with an explosion occurring within this assembly.

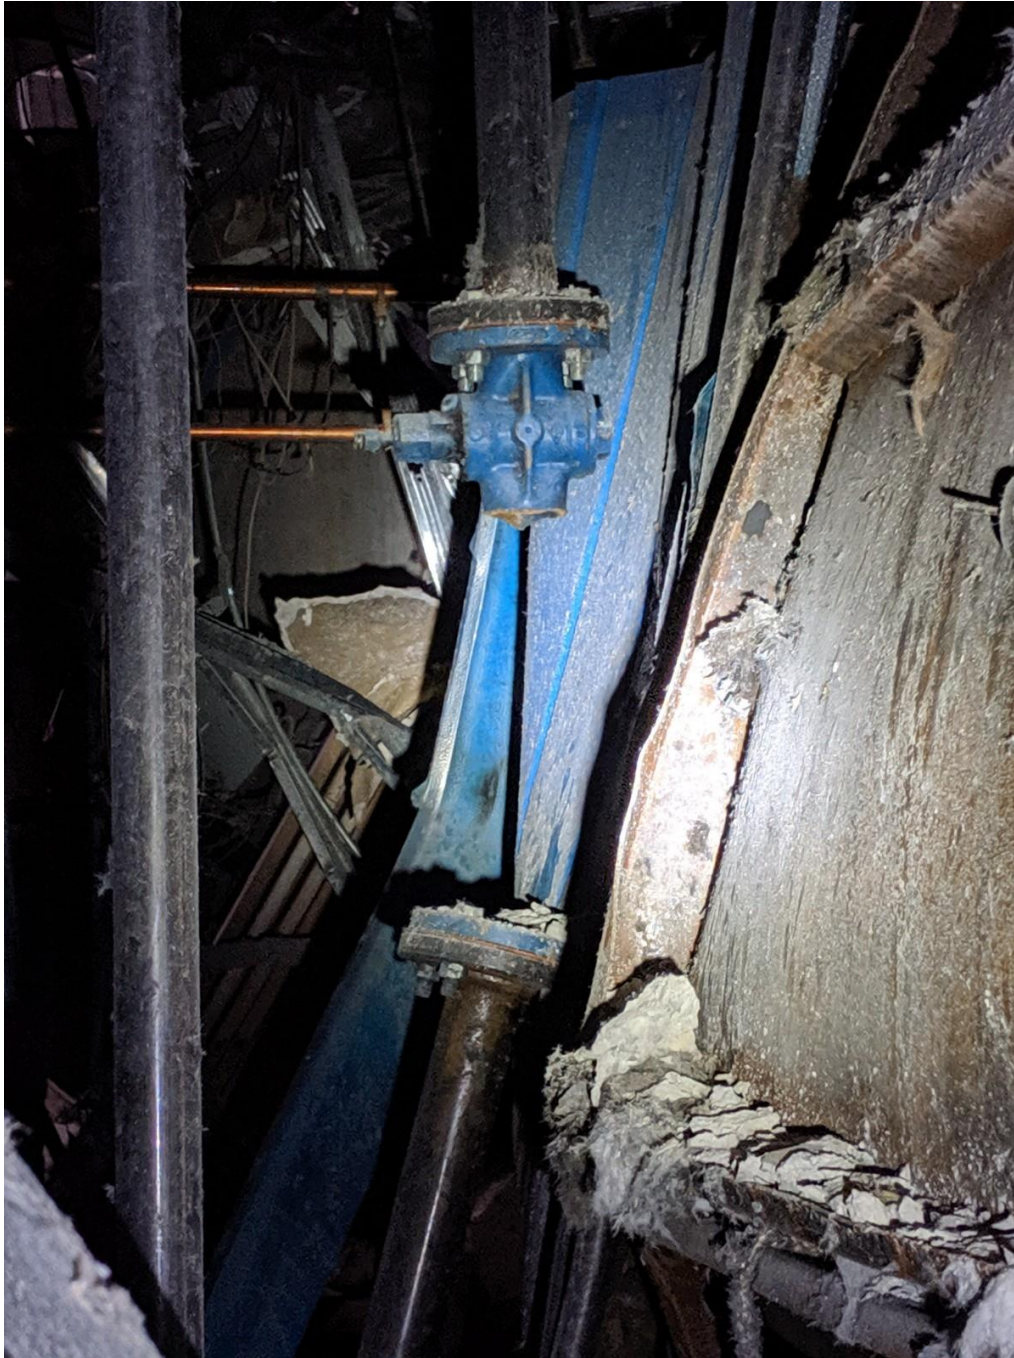
As a direct result of the explosion of Boiler #1, the 3-inch gas supply line to the boiler, which descended from the ceiling directly next to the body of the boiler, was severed at the point of the primary gas shut-off valve (see figure 4). This valve exhibits evidence of combustion consistent with a torch effect, which is consistent with the boiler mechanic's claim of fire coming from the area of this valve immediately following the explosion of the boiler.

The primary fuel shut-off valve for the Boiler #1 fuel train was damaged during the initial explosion. However, it could not have been actuated after the initial explosion due to the fact that it was, until the actuation of the fire sprinklers, acting as a source of flame. Additionally, the shut-off handle for this valve was not installed at the time of the initial explosion, and thus the valve could not have been actuated (handles are required to be "permanently attached" per the American Society of Mechanical Engineers Controls and Safety Devices for Automatically Fired Boilers [ASME CSD-1], 2012 version, section CF-150[a]). All other valves in the Boiler #1 fuel train were tested and found to be functioning as designed.

**Figure 4.** A view of the primary gas shut-off valve on Boiler #1 exhibiting damage from the initial explosion.

Evaluation of the causes of both explosions suggests that the inclusion of an electrically actuated gas shut-off valve upstream of the boiler fuel train and relocation of gas feeder lines away from areas of potential damage during a boiler explosion would be effective means to mitigate future similar occurrences. It is recommended to require such means via future revision to the Nevada Administrative Code.

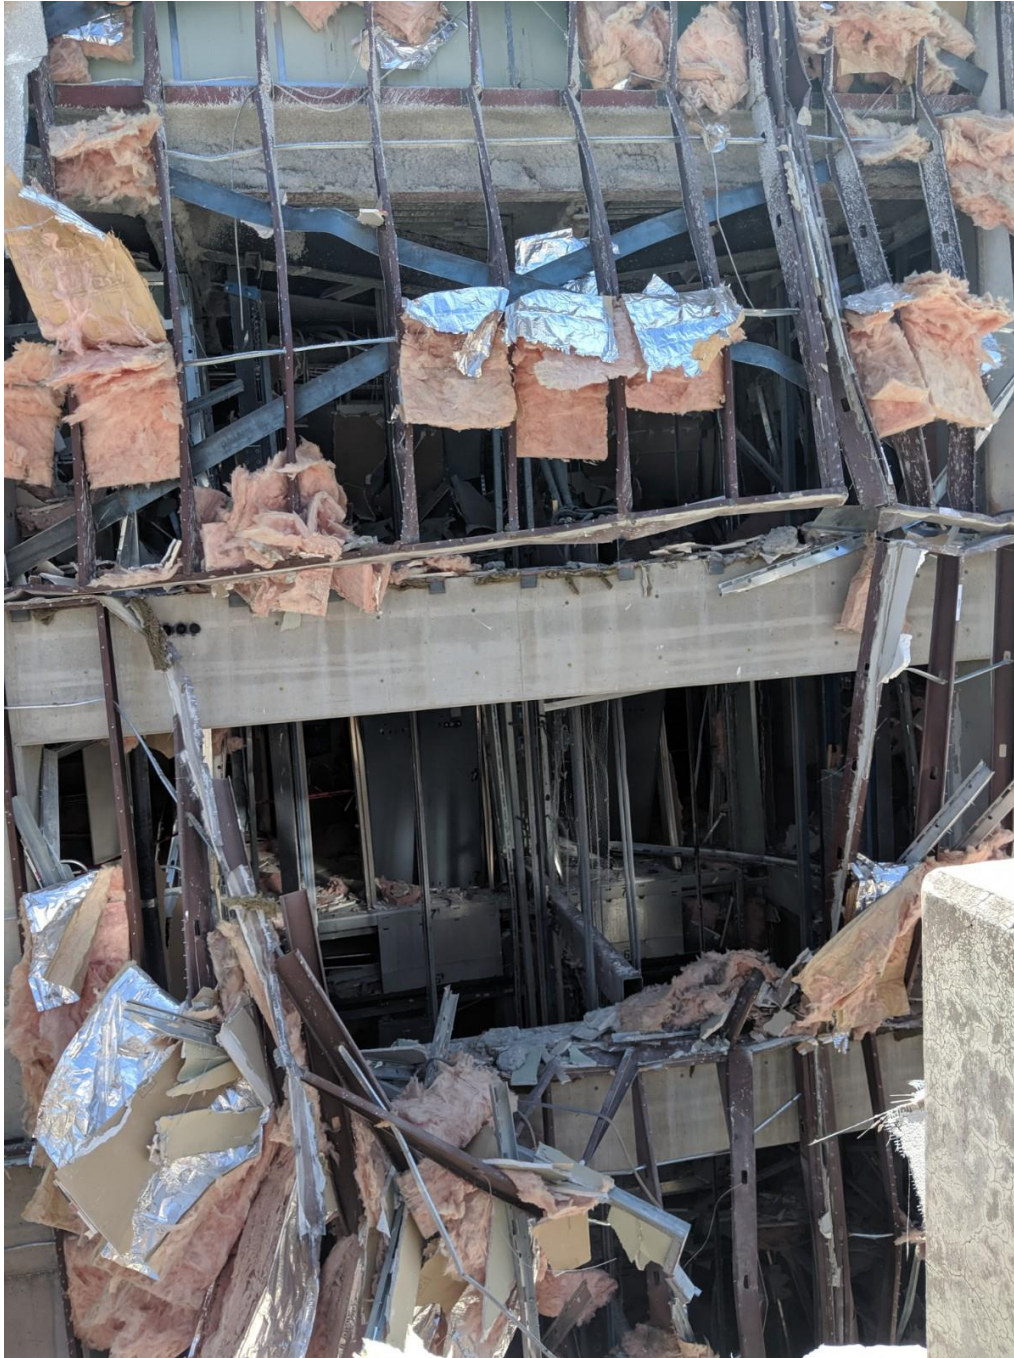
Damage to Argenta Hall shows that the boiler room and adjacent elevator hoistway were filled with gas during this time. When ignition of the gas occurred, these areas sustained greater blast damage than other areas of the building (see figures 5 and 6).

**Figure 5.** Argenta Hall elevator hoistway, as seen from the roof of Nye Hall. Damage is consistent with a significant blast pressure wave caused by a gas explosion.

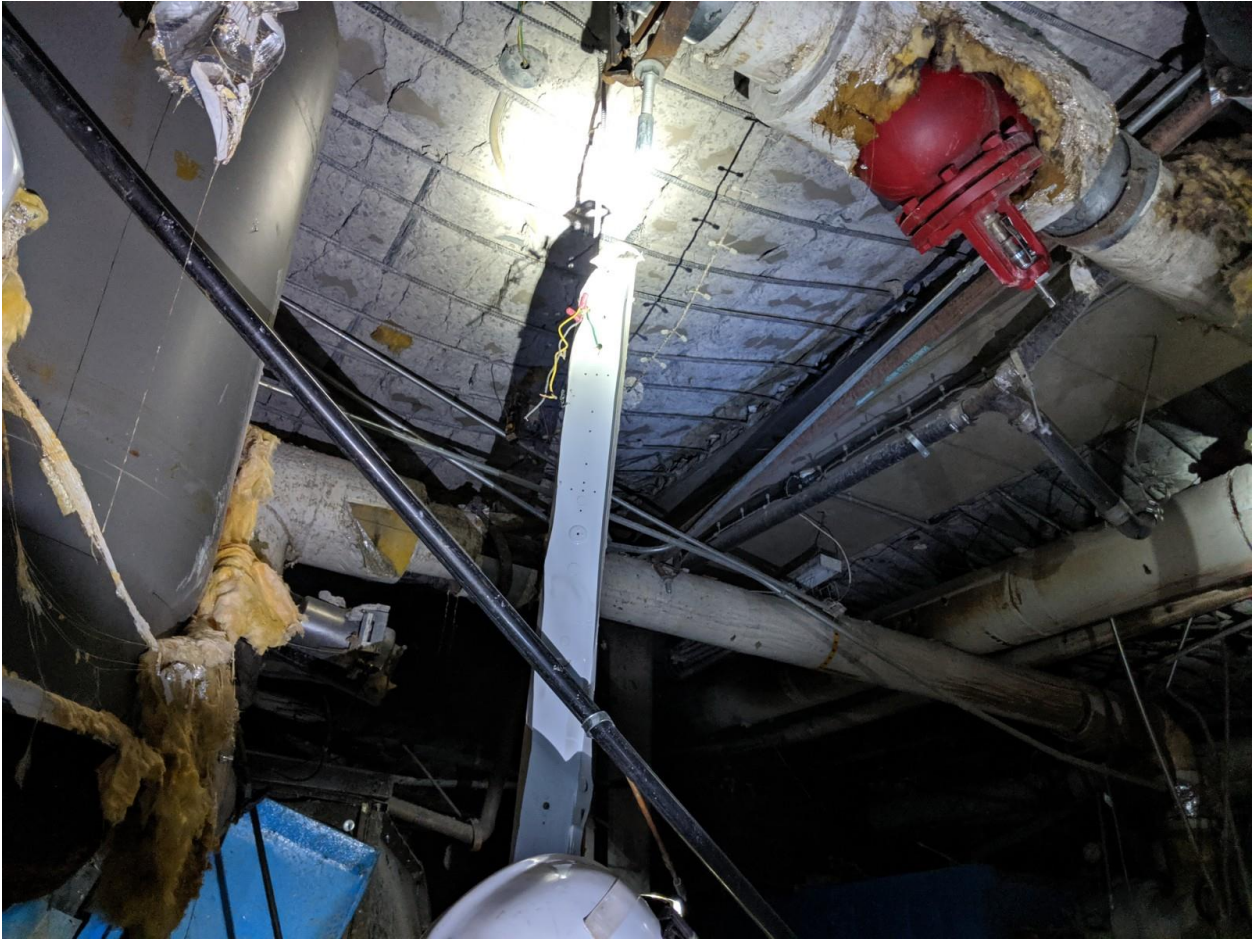
**Figure 6.** Ceiling of the boiler room. Damage is consistent with a significant blast pressure wave caused by a gas explosion.
