## National Transportation Safety Board Aviation Accident Factual Report

<b>Location:</b>	Crozet, VA	<b>Accident Number:</b>	ERA18FA127
<b>Date &amp; Time:</b>	04/15/2018, 2054 EDT	<b>Registration:</b>	N525P
<b>Aircraft:</b>	CESSNA 525	<b>Aircraft Damage:</b>	Destroyed
<b>Defining Event:</b>	Loss of control in flight	<b>Injuries:</b>	1 Fatal
<b>Flight Conducted Under:</b>	Part 91: General Aviation - Personal

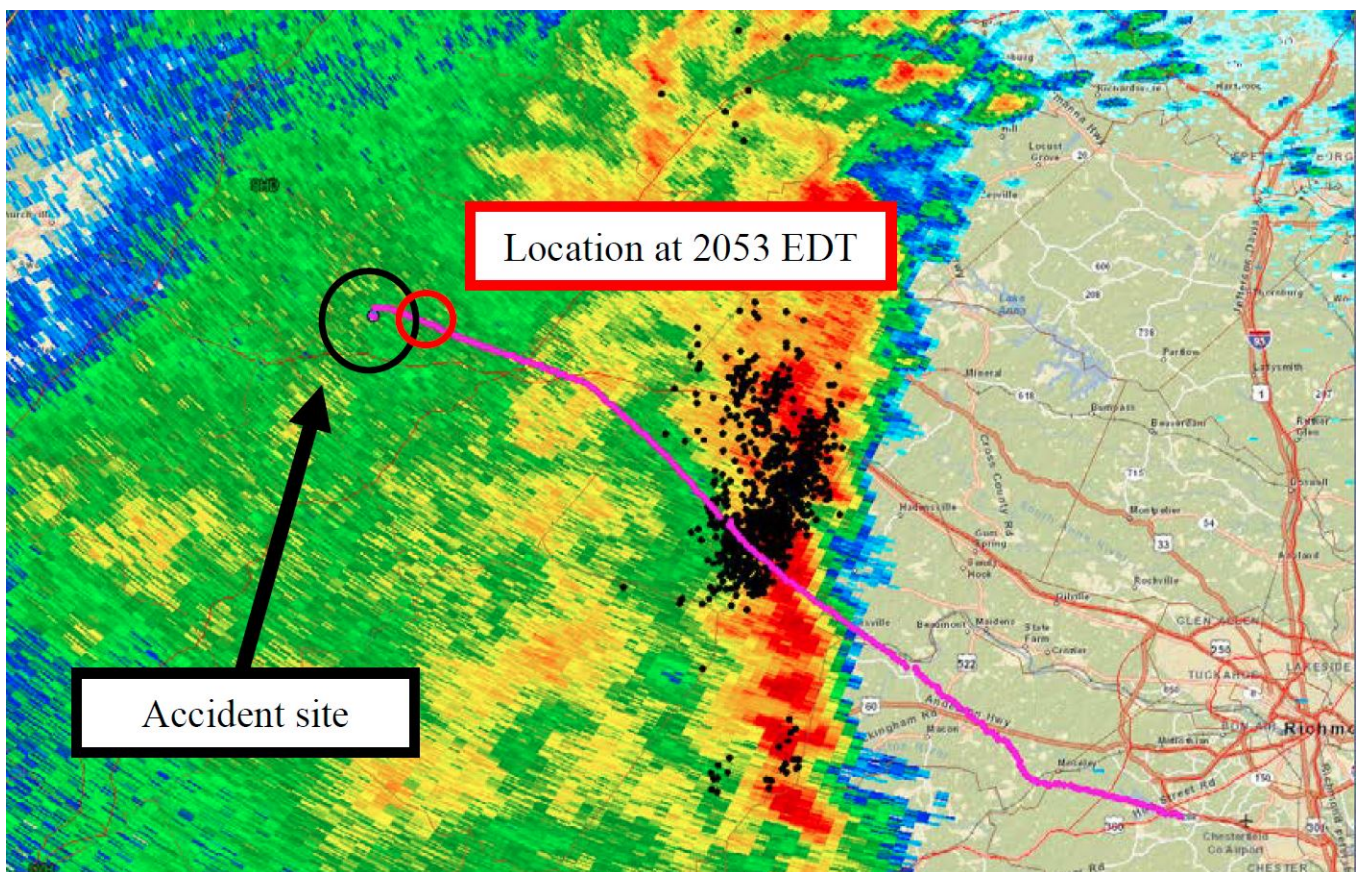
According to reviewed radar data, reflectivity values between 25 and 35 dBZ were located above the accident site at 2053 (see figure 1), which corresponded with the surface observation precipitation reports from W13, SHD, and CHO. The reflectivity bands were moving from south-southwest to north-northeast between 2004 and 2103. The reflectivity targets indicated of moderate-to-heavy rain moving northward across the accident site at the accident time.

The accident airplane flew through a thunderstorm line between 2042 and 2047. There were no lightning strikes within 10 miles of the accident site about the accident time.

Figure 1. Radar reflectivity at 2053 with the accident site marked with a black circle, the accident flight track in pink, the airplane's position at 2053 marked with a red circle and the lightning flashes represented by the black dots.
